NEAR MISS REVIEW

Report Type:	Near Miss Event		
Department/Area:	Paint Prep, Building 1		
Date:	1-29-2026	Time:	7:00AM

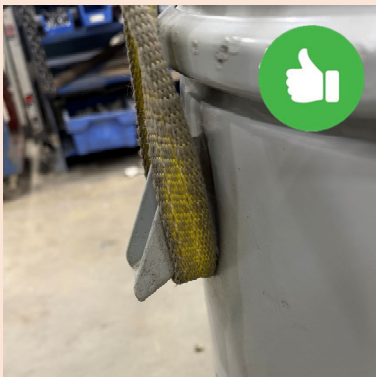
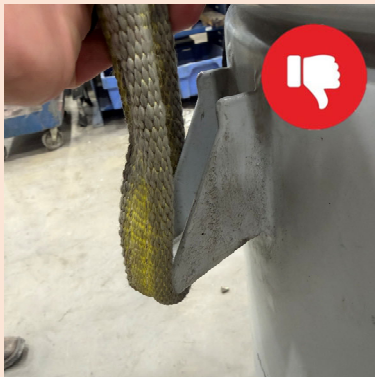
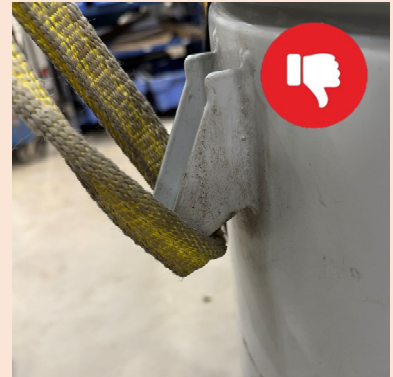
Description: Single-phase pole was suspended in the air while sanding/prep was taking place on the bottom of the unit. While the operator stepped away the pole twisted slightly in the sling and fell to the ground. As the pole fell the lifting sling disengaged from the hoist hook damaging the hook's safety latch.

Root Cause: The lifting ring was not fully seated into the unit's lifting hook, allowing the transformer to slip off during the natural twisting of the suspended pole.

Ensure lifting rings are fully seated under the transformer's lifting hooks

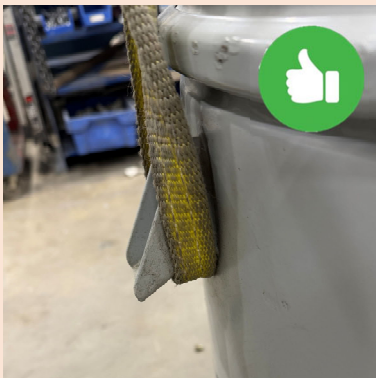
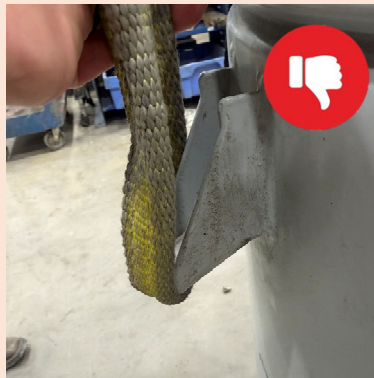
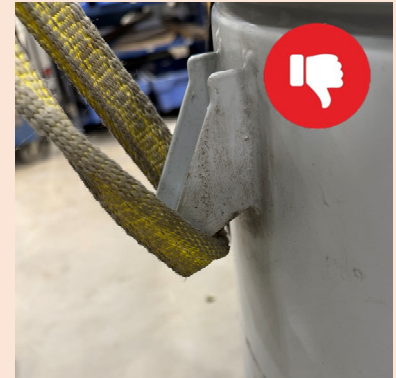
Descripción: Un poste monofásico estaba suspendido en el aire mientras se realizaban trabajos de lijado y preparación en la parte inferior de la unidad. Mientras el operario se ausentó momentáneamente, el poste giró ligeramente en la eslinga y cayó al suelo. Al caer, la eslinga de elevación se soltó del gancho de la grúa, dañando el pestillo de seguridad del gancho.

Causa raíz: La anilla de elevación no estaba completamente encajada en el gancho de elevación de la unidad, lo que permitió que el transformador se deslizara durante el giro natural del poste suspendido.

Asegúrese de que los anillos de elevación estén completamente encajados debajo de los ganchos de elevación del transformador.
